EB CURING OF VARTM FABRICATED MARITIME COMPOSITE STRUCTURES

Contract USZA22-97-P-0013
CDRL A002

September 19, 1997

DAMILIC Corporation
14670 Southlawn Lane
Rockville, MD 2085

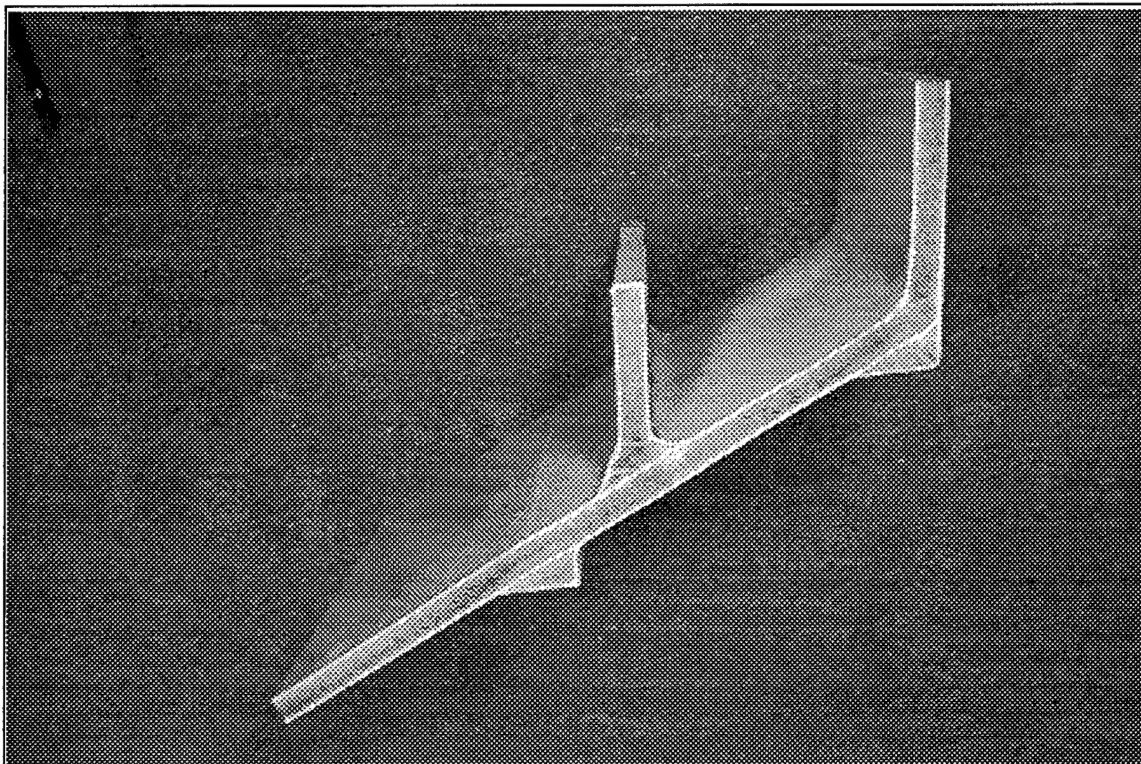
Figure 1: Demonstration section of boat hull cured with EB radiation.

The part was layed up on inexpensive wood/formica tooling. A vacuum assisted resin transfer molding technique was used for resin infusion. Immediately after resin infusion, the part was irradiated as required to achieve satisfactory cure. Although the cure was sufficient throughout the part, delamination was observed in several regions of the part. The delamination zones appear to be "resin starved", implying that the delaminations resulted from the resin infusion process, not the EB curing step.

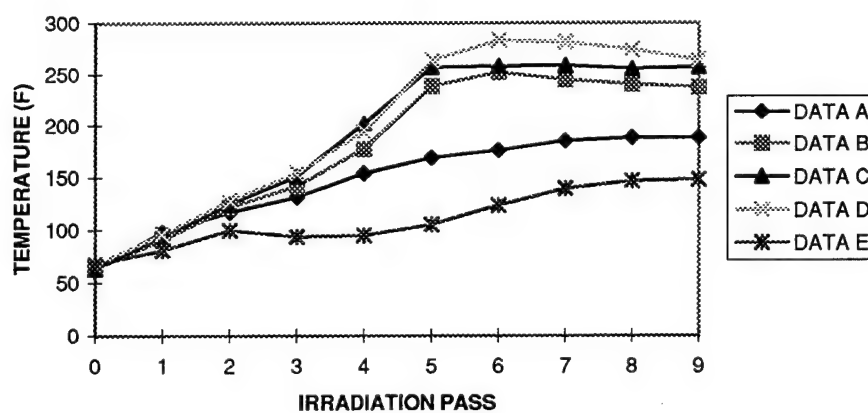
Because EB cures can be achieved at room temperature, no special consideration for high temperature operation was included in the tool design and construction. Unfortunately, the elevated temperature (ref. Figure 7), resulting from exothermic reaction during cure, exceeded the rated operating temperature of the epoxy fillet. This resulted in loss of vacuum during the EB cure, exacerbating the part's delaminations, and some local contamination of the hull outer surface with epoxy. This particular tool will require some minor rework for additional use. However, the use of a more appropriate epoxy would render this tool reusable for many production runs.

Figure 7: Temperature of thermocouples imbedded in part following each irradiation pass.

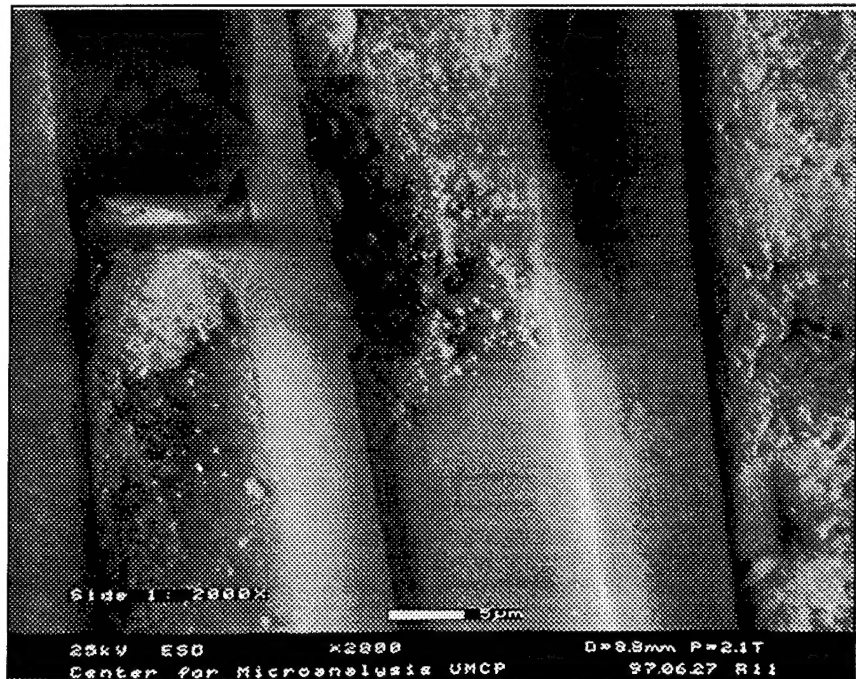
The cause of the delamination appeared to be a lack of proper wetting. Samples of fiber were removed for microscopic evaluation. Optical inspection was not more conclusive, so further magnification to 2000 X using a scanning electron microscope confirmed insufficient wetting in the region of delamination (Figure 10), while the sample from a region having no delamination exhibited complete coverage of the fibers with resin (Figure 11).

Figure 11: Fibers in region with no delamination have complete resin coverage.
